USACERL Technical Report 98/34  
January 1998

# Seismic Mitigation for Equipment at Army Medical Centers

Methods Illustrated With Examples from Madigan Army Medical Center

by  
James Wilcoski

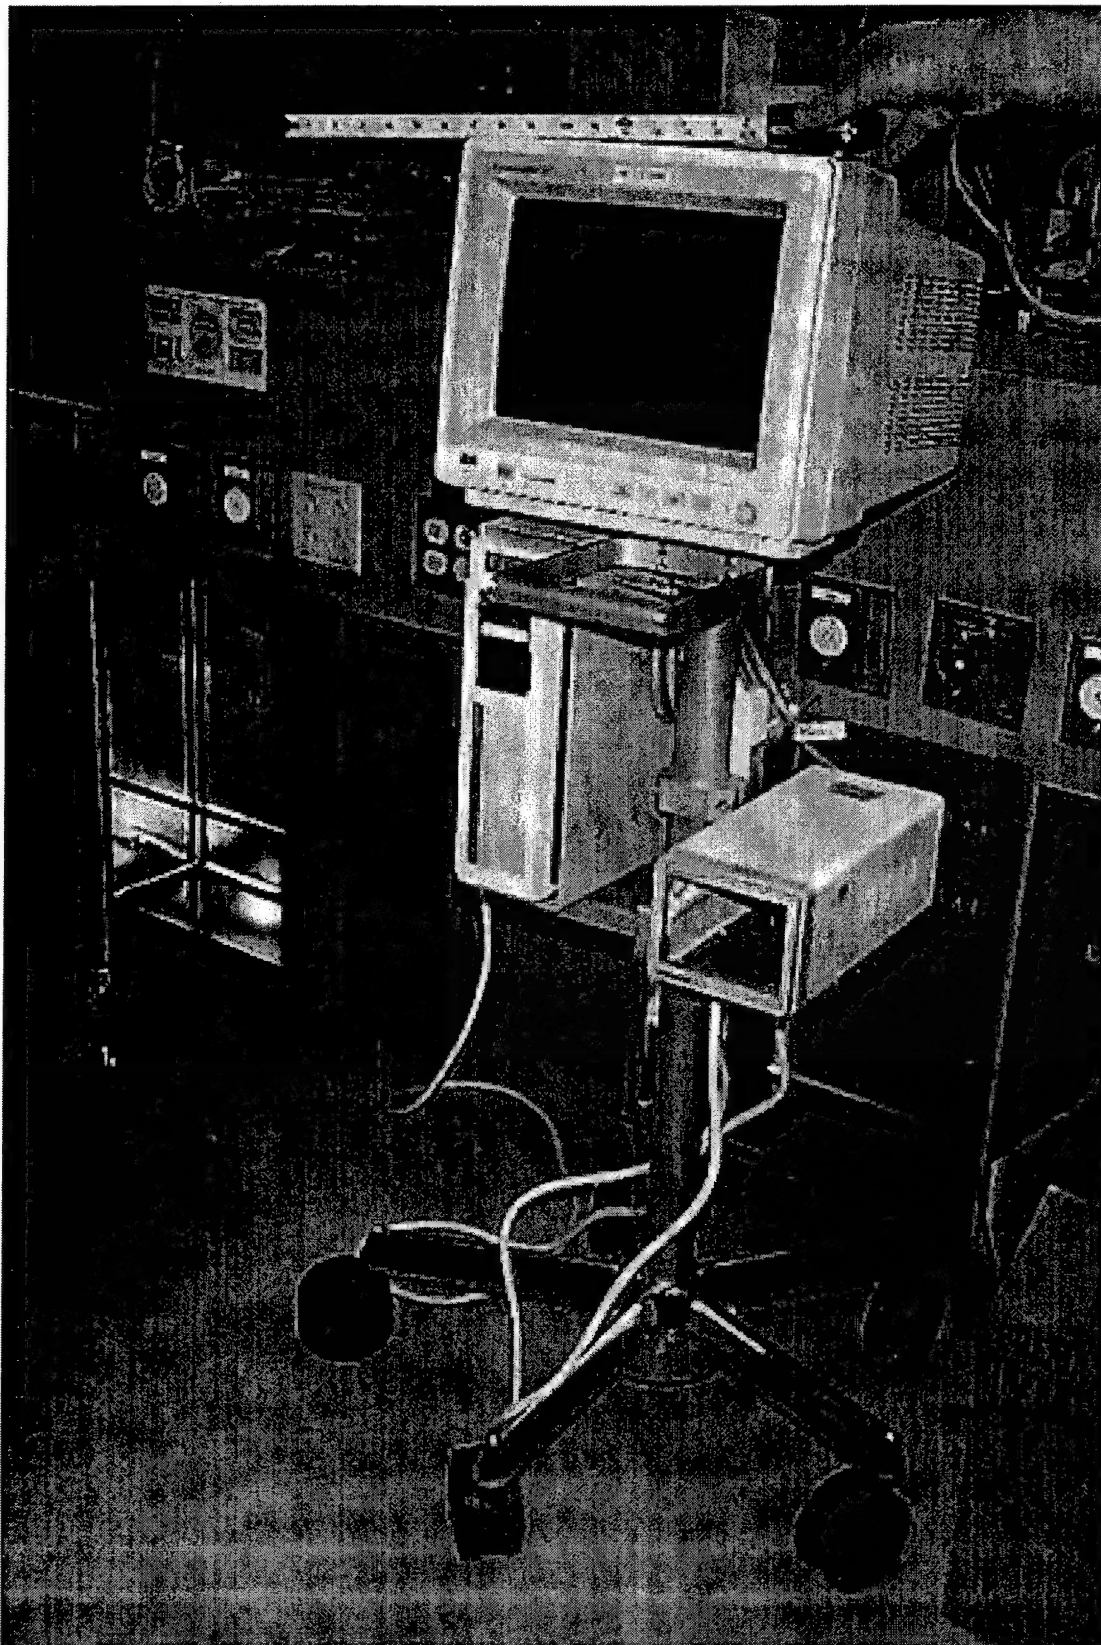
Figure 48. Monitor on wheels with a very narrow wheelbase.

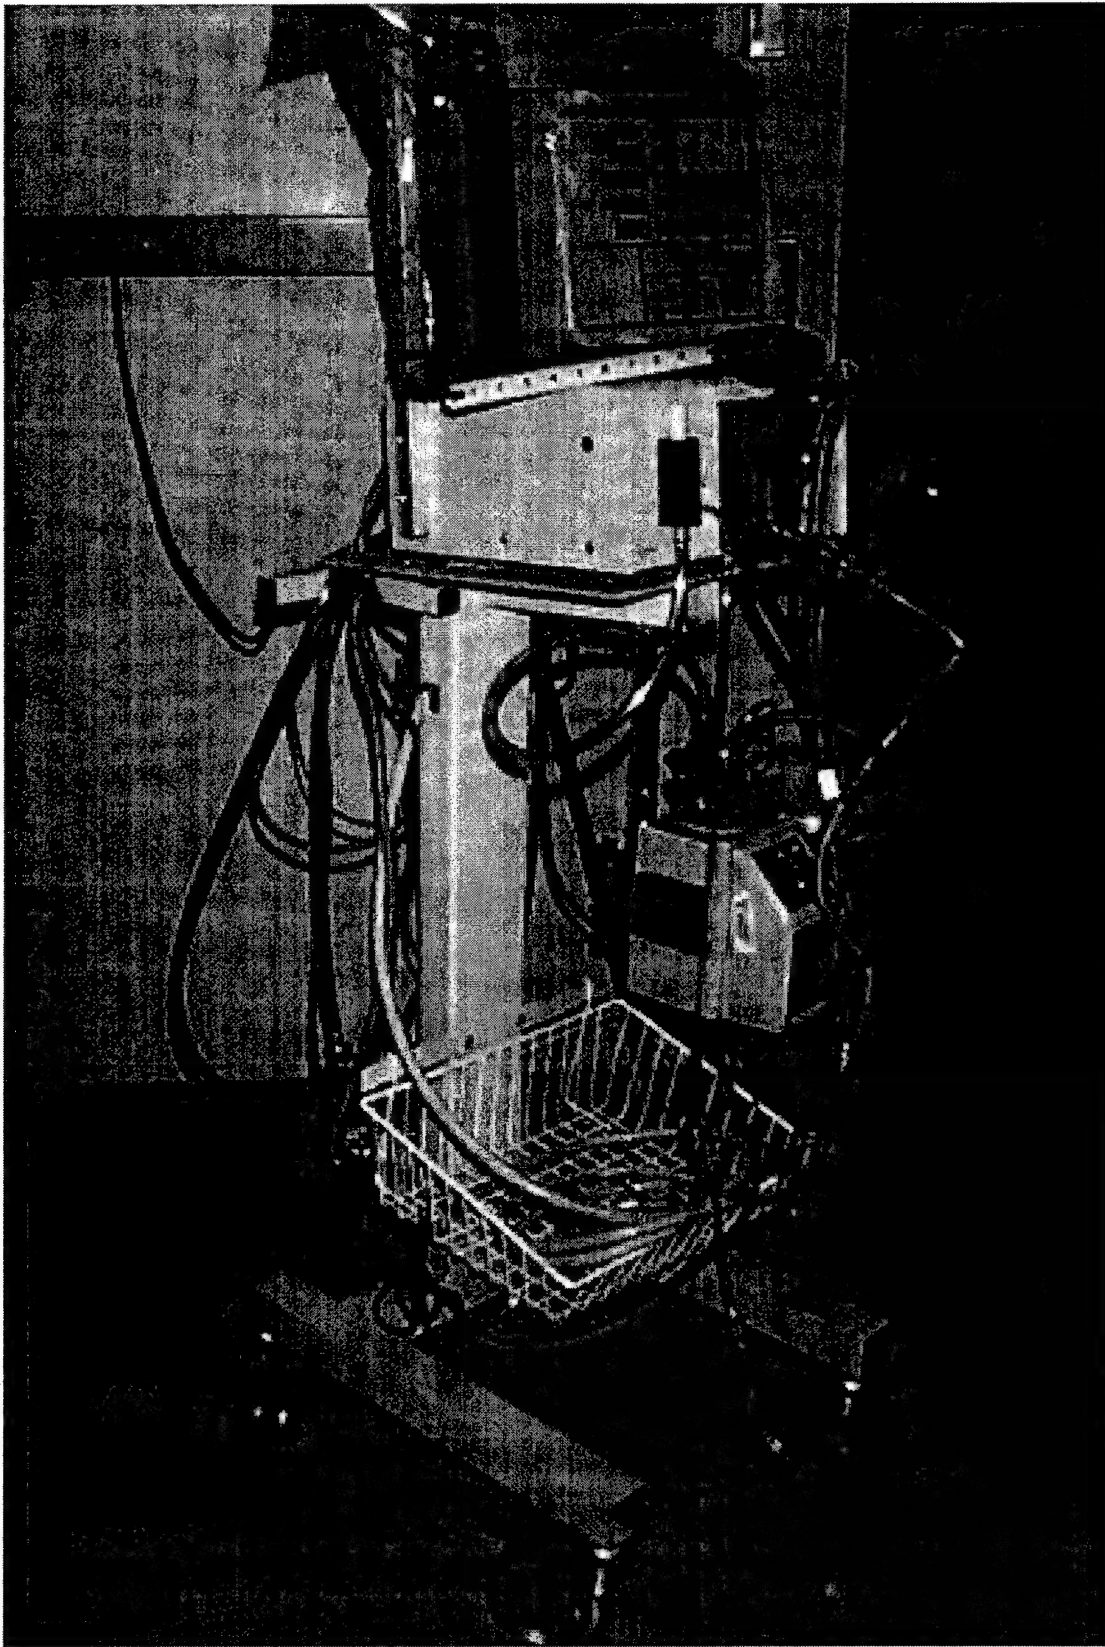
impact may damage either the equipment on wheels or whatever it hits, such as gas lines in intensive care units. It is recommended that the wheels on all such equipment be kept locked. Even with the wheels locked this equipment may fall over if the wheelbase is not wide enough relative to the height of the equipment center of gravity. If such equipment cannot be anchored, it can only be protected by increasing the wheelbase or lowering the center of gravity. Equipment on rollers was seen in the emergency room communications center, intensive care unit (ICU) rooms, ICU nursery, delivery rooms, operating rooms, and in the area near gamma ray cameras. Figure 47 shows a nursery bed on wheels in the ICU nursery. Figure 48 shows a monitor on wheels with a very narrow wheelbase. Figure 49 shows other equipment with a narrow wheelbase near the ICU nursery.

Figure 49. Other equipment on wheels with a narrow wheelbase.

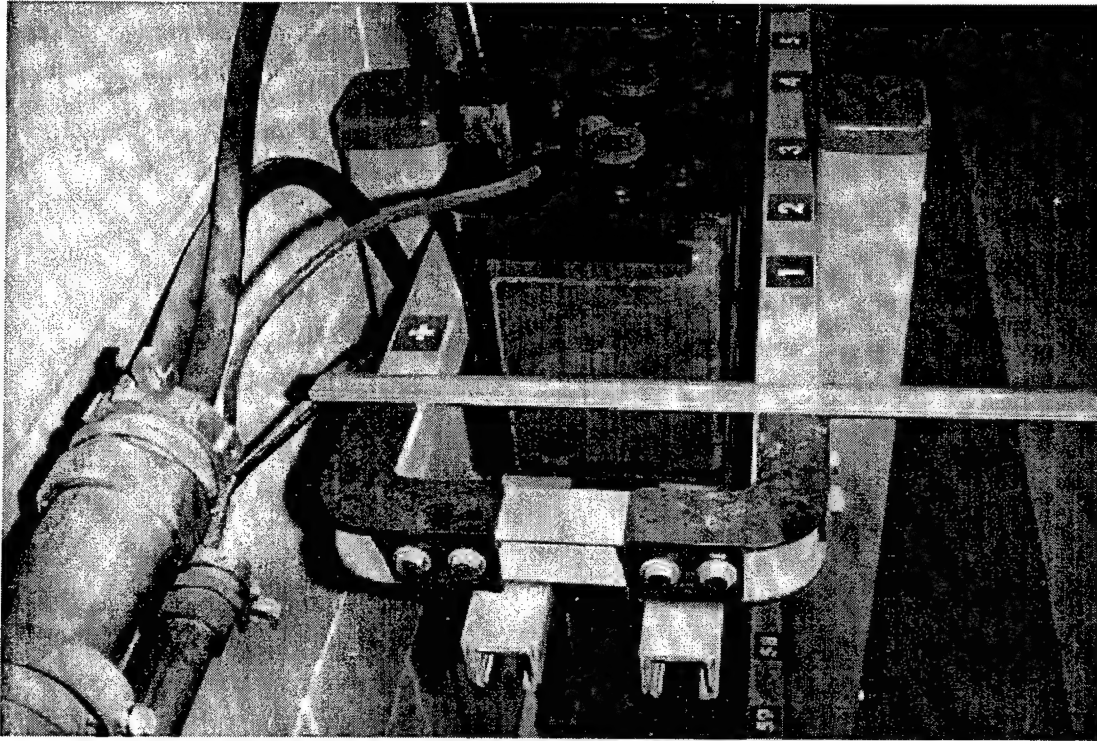
Figure 50. Close-up of station batteries showing lack of foam spacers.

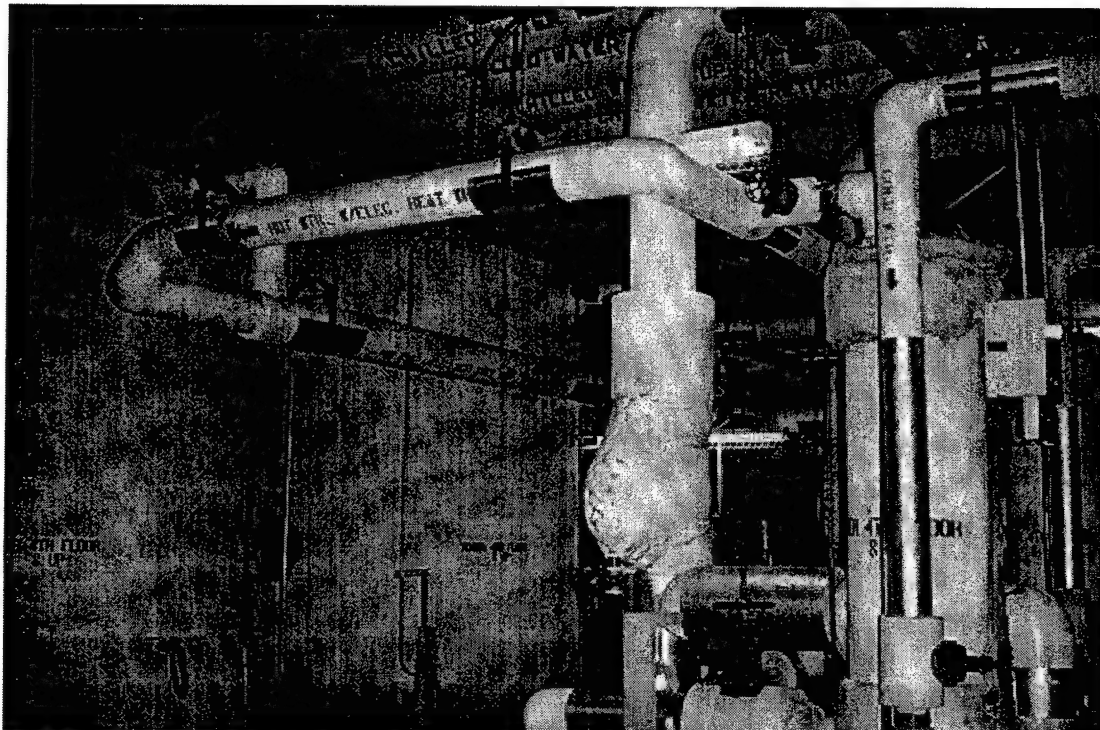
On the left-hand edge of Figure 51 a large hot water tank can be seen. A 4 in. (10 cm) pipe (approximate) connected near the top of this tank couples it to a much smaller tank near the right edge of Figure 51. The pipe is primarily horizontal near the top of photograph in Figure 51. This coupling pipe may cause a problem by not allowing differential movement because it will be very rigid along its axis. In an earthquake the larger tank will oscillate at its own natural frequency, with relatively large displacements near its top. The connecting pipe will then drive the top of the second tank, in the direction of the pipe's axis, with the same motion as the top of the first tank. However, this motion will have a different frequency, phase, and amplitude than the natural motion of the smaller tank. It is important to determine whether the supports for the smaller tank can handle the displacements and forces placed upon them, and whether the pipe connections can withstand the forces placed upon them. Determining the answer to this seismically induced forced vibration problem would require further study. However, this example does demonstrate the potential problems created by the elimination of differential movement when equipment is coupled together.

Figure 51. Large hot water tank coupled to smaller tank, restraining differential motion.

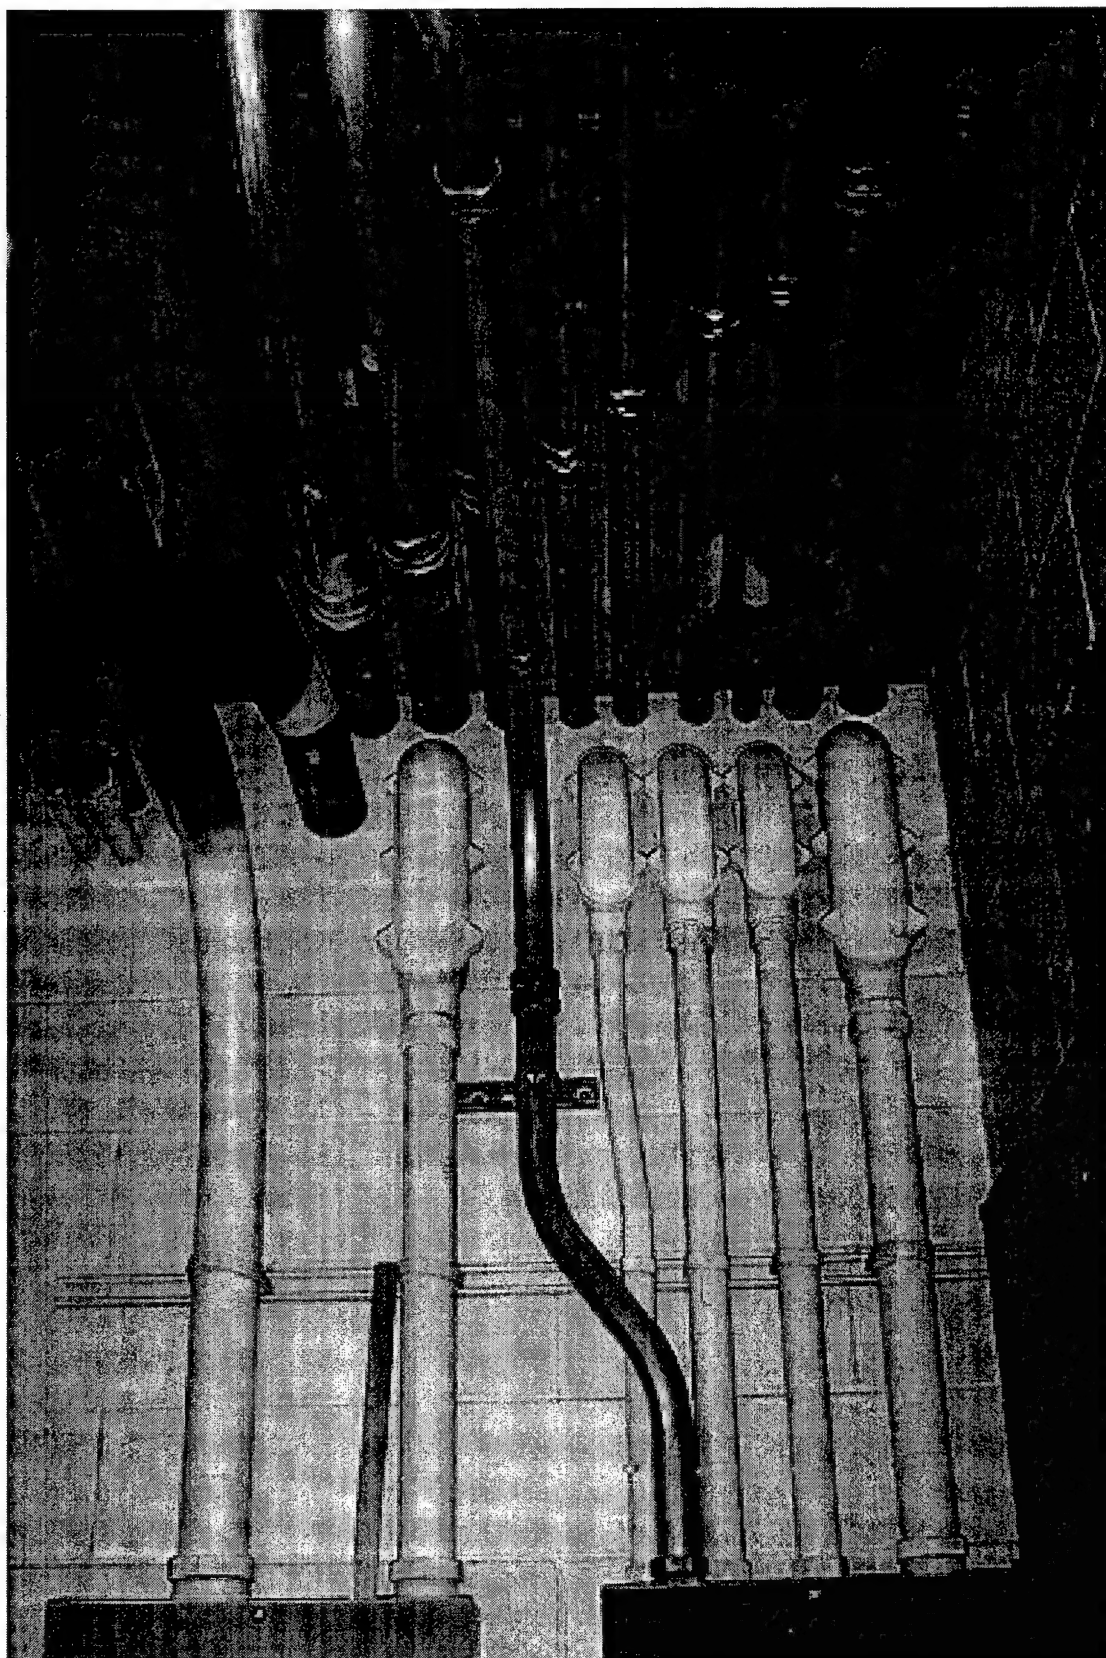
Figure 52. Heavy conduit penetrating CMU wall, loading wall out-of-plane.

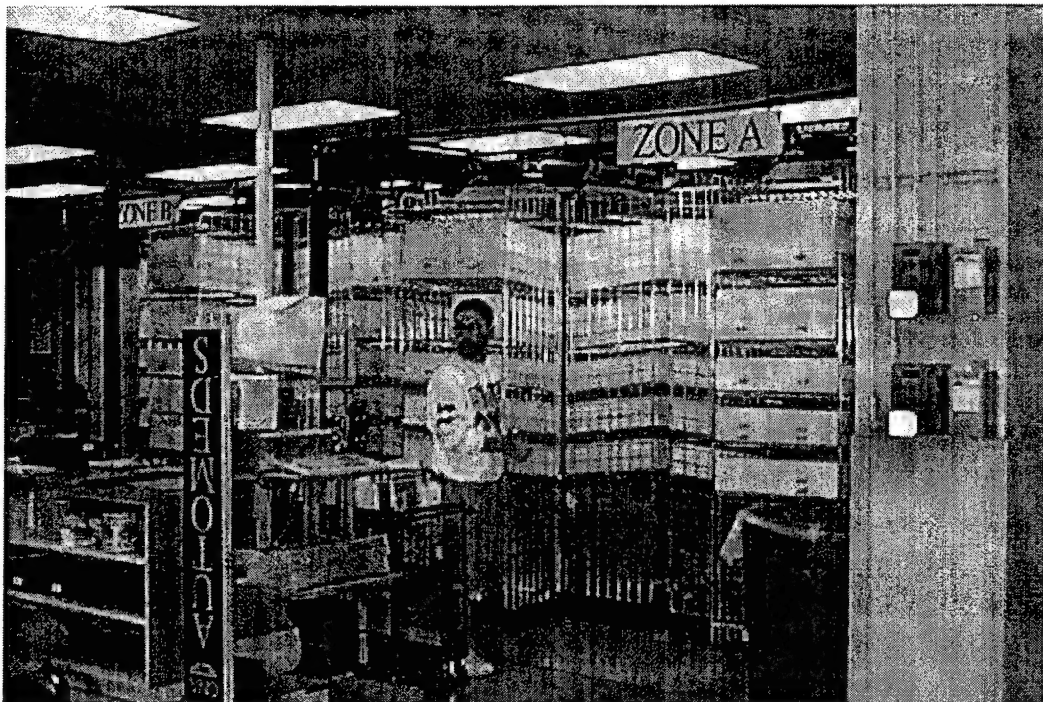
The outpatient pharmacy is supplied by the automated storage racks shown in Figure 53. These movable racks provide 10 days of supply storage. The racks are supported with a structural floor and frame designed to carry 1000 lb (453kg) per 2 x 2 ft (in plan) and 7 ft tall (0.6 x 0.6 x 2.1 m) unit. According to MAMC personnel responsible for this area, the actual weight per unit rarely exceeds 200 lb (90 kg). The logistics area has similar storage racks; their contents appear somewhat heavier, but still well within frame capacity. These frames are approximately 60 ft deep (front to back) and move clockwise along a horizontal track in such a way that racks on the right move toward the front while racks on the left move toward the rear. Therefore, one frame supports about 120 linear feet of 2 x 2 x 7 ft storage units. The pharmacy is equipped with five of these frames. The frames are well anchored to the floor and they appear to be well braced to carry seismically induced lateral loads. The storage units appear to be well supported, with all vertical loads carried along a track at the tops of the frames. The bottoms of these units are restrained by a roller from swinging in against a support bar on the frame, but they are free to swing out — particularly away from the track ends. The racks of one frame are separated from the racks of the parallel frame by only 6 in. Figure 54 shows the bottoms of the racks of two such frames, with the 6 in. separation seen in the center of the photo. In the center of this photo a box has been laid to span across between the two frames. In an earthquake, these frames will be free to swing out at their bottoms, striking the adjacent racks. Immediately after an earthquake begins the racks should be shut down so this impacting will not bind the racks to each other. However, rack contents such as the box shown in Figure 54 will probably fall out of the racks, or to an adjacent rack, or get wedged

between the racks, preventing the operation of the racks temporarily. This debris would need to be cleared away by manually removing rack units, climbing into the racks and removing the obstruction. It may require several hours to clear away the debris but should not cause a long-term problem. If someone attempts to operate the racks before removing this debris, the racks could be forced out of position and bind to each other. If this happened, the rack units or frames could twist, resulting in the need for time-consuming repairs. Therefore, after an earthquake, the racks should be inspected and debris removed to prevent longer-term problems. Figure 54 shows that the base of each rack section slopes in toward the center of the frame, which would help to retain most contents during an earthquake. The actual loss of rack contents should be minimal.

Figure 53. Front view of automated storage racks in the outpatient pharmacy.

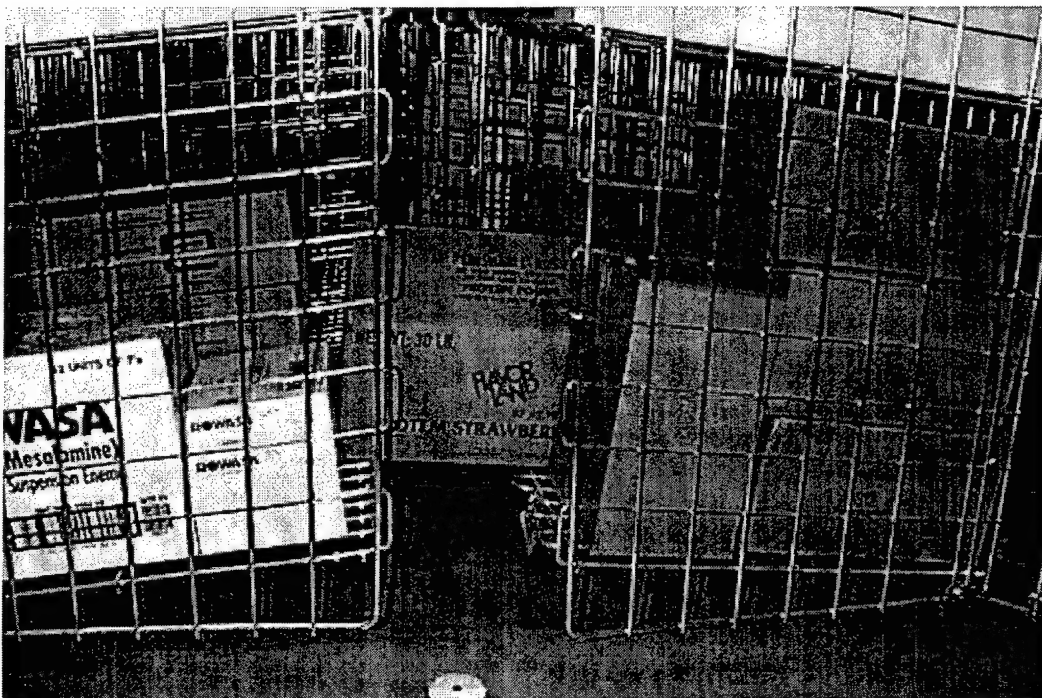
Figure 54. Close-up showing narrow gap between racks at bottom of automated storage racks.

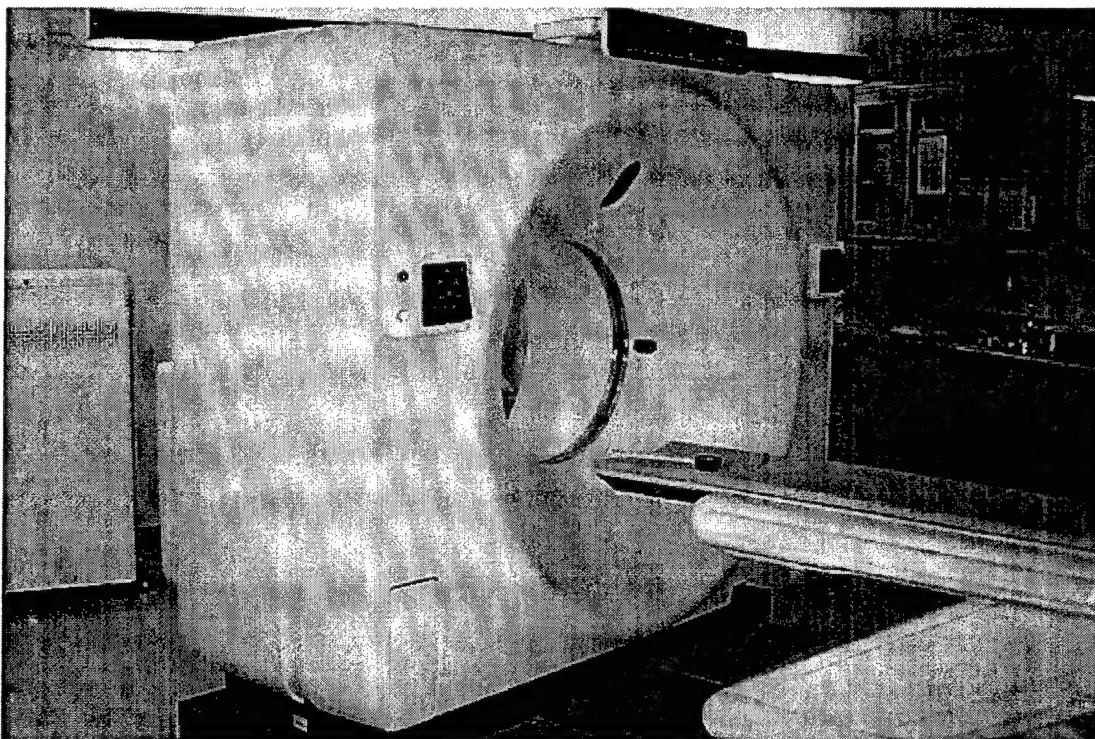
Figure 55 shows a General Electric (GE) computed tomography (CT) scanner. According to medical staff at MAMC, the x-ray tube and detector array rotate in the circular ring shown in Figure 55. These can easily move out of alignment during a seismic event — particularly while spinning. The CT scanner may be the most vulnerable medical equipment at MAMC and, as noted previously, is of particular concern to medical staff.

Figure 55. General Electric CT Scanner, potentially the most vulnerable equipment at MAMC.

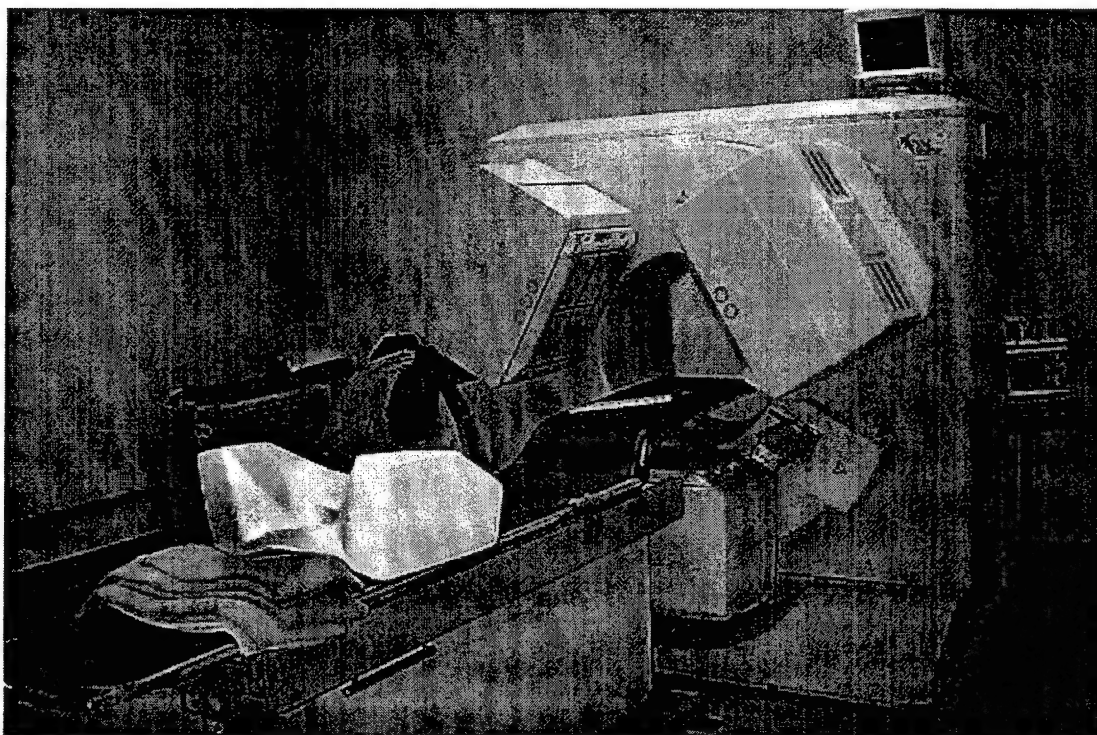
Gamma ray cameras of various types, all manufactured by Siemens, were seen at MAMC. These include the single-head Orbiter, a single-square-head Diacam, and a triple-head Prism 3000 gamma camera. The triple-head camera is shown in Figure 56. Each head in this camera contains 60 glass tubes in rows, costing \$3000 per tube. USACERL inspected the Sepulveda Veterans Administration (VA) Medical Center, which is located about 20 miles (32 km), Northwest of downtown Los Angeles, CA, shortly after the 1994 Northridge Earthquake. Figure 57 shows a single-head gamma camera that was damaged in the Northridge event. The camera was well anchored to the floor, but the mechanism at the base of the cantilever arm supporting the head was damaged.

Figure 56. Triple-head Prism 3000 Gamma Camera.

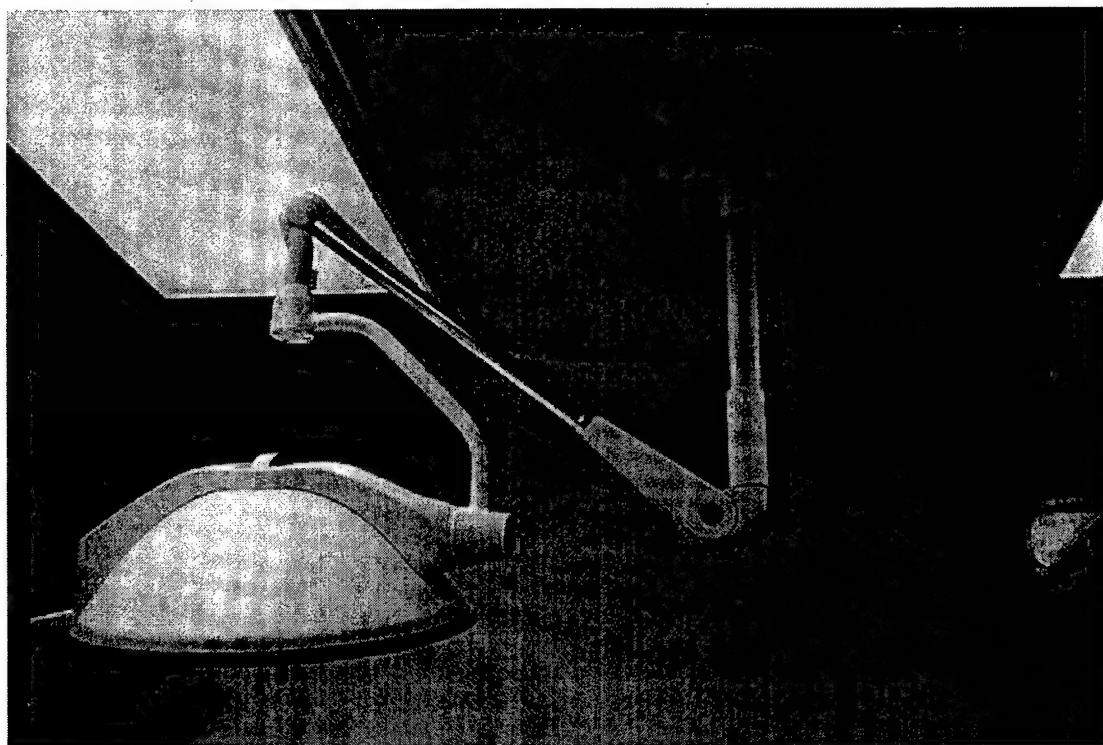
Overhead examination lights such as the one seen in Figure 59 are located throughout MAMC. These are well anchored to the roof above, but the supporting arm appears questionable, especially when fully extended. These may have been seismically qualified, but further investigation is needed to verify that.

**Figure 59. Overhead examination light, typical of those located throughout MAMC.**
